# ALERT SERVICE BULLETIN

## Alert Service Bulletin No. 074

### **Turbocharger Center Housing Inspection**

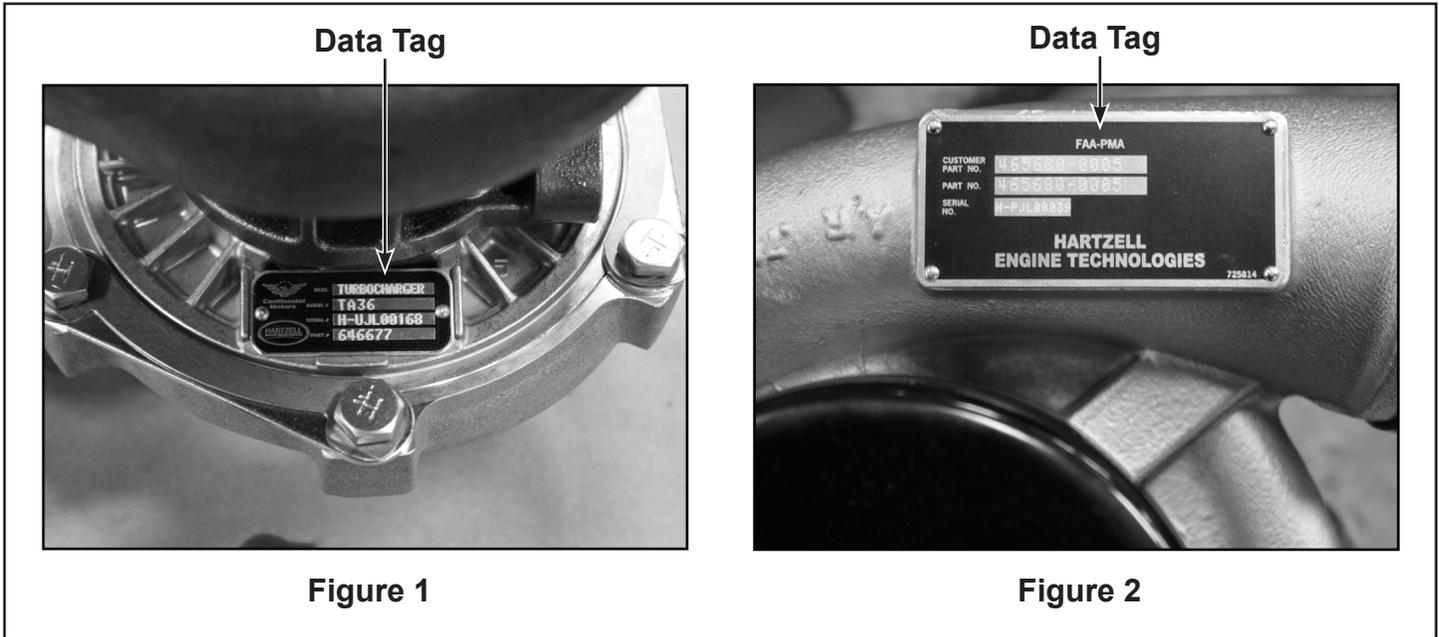
Turbocharger Data Tag Locations  
Figures 1 & 2

**NOTE :** The turbocharger data tag can be found in one of two locations depending on model. Refer to Figures 1 & 2 for locations.

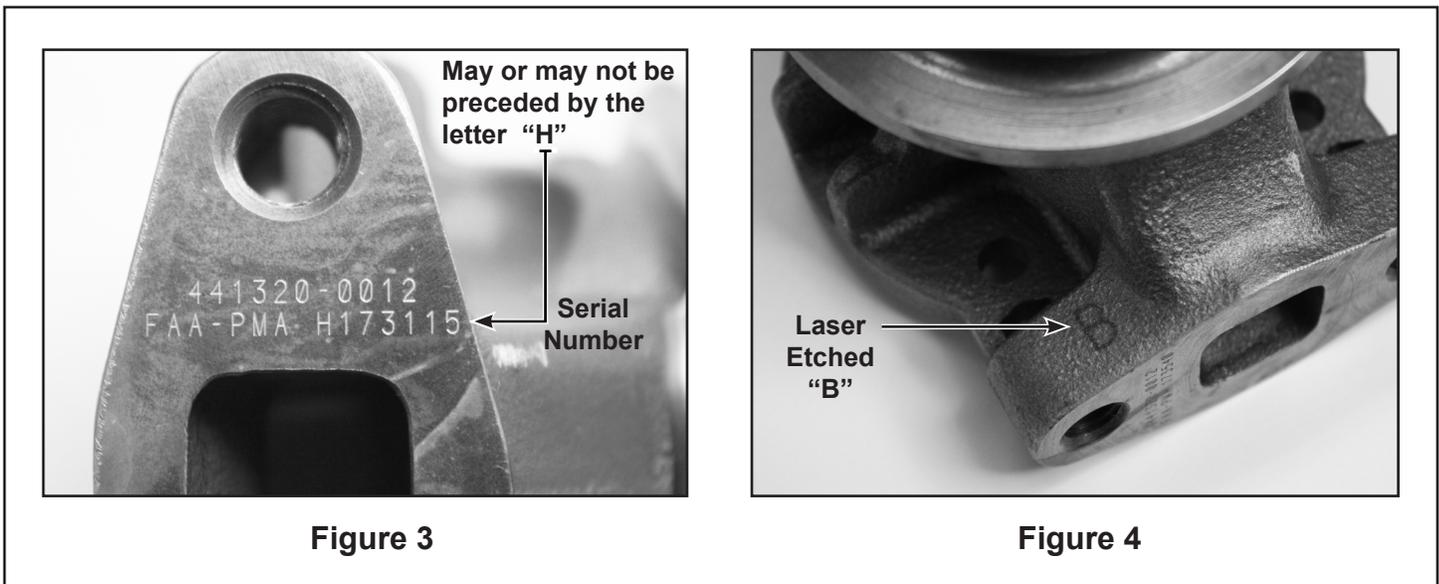
Turbocharger Center Housing Oil Drain (lower) Flange  
Figures 3 & 4

- (3) If the turbocharger was serviced between 10 May, 2017 and the effective date of this ASB, and effectivity cannot be established from the maintenance records, utilize the applicable aircraft maintenance manual to gain access to and remove the turbocharger center housing oil drain line from (lower) flange. Inspect turbocharger center housing serial number against affected serial numbers found in Table 2 of this ASB. (See Figure 3 for serial number illustration)

**NOTE:** Serial numbers found in Table 2 may or may not be preceded by the letter “H” as shown in Figure 3.

- (1) Affected turbochargers and/or center housings
  - (a) Replace turbocharger center housing with one not associated with this ASB.
    - 1 Replacement center housing may be new or factory reworked.
    - 2 Factory reworked center housings will be identified by a laser etched “B” located on the side of the oil drain flange (See Figure 4).
