2900 Selma Highway Montgomery, AL 36108 USA Tel: 334-386-5400 Fax: 334-386-5450 Service Letter No. 073

TA04 & TA36 Turbocharger Left-Hand Thread Turbine Wheel Assembly Change Notification

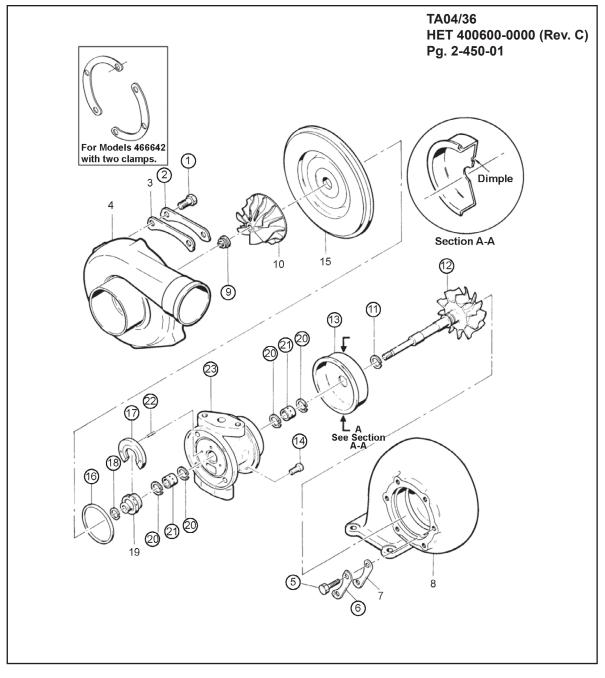
Turbine Wheel Assembly (Itm# 12) and Compressor Wheel Nut (Itm# 9) Figure 1.1

- D. Description
 - (1) This Service Letter addresses affected turbocharger part numbers that have a design modification which changes the affected Turbine Wheel right-hand thread assembly and Compressor Wheel Nut to a Turbine Wheel left-hand thread assembly and Compressor Wheel Nut. See Figure 1.1 for Turbine Wheel Assembly and Compressor Wheel Nut illustration.
