# Service Information Letter

Bulletin No. A-111

## RECOMMENDED SERVICE/INSPECTION FOR CESSNA 402C EXHAUST BY-PASS VALVE ASSEMBLY

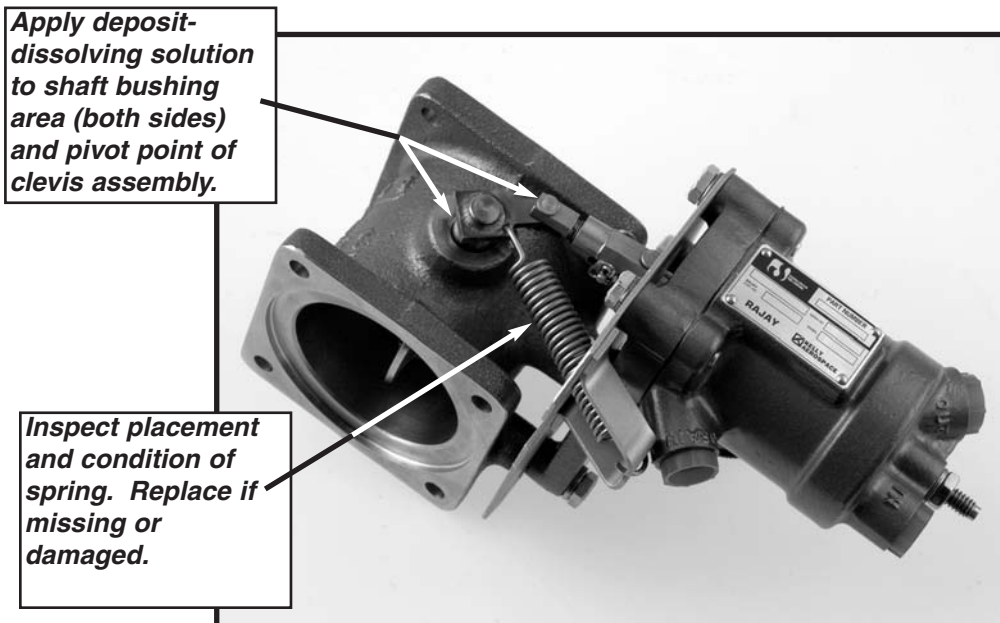
**Exhaust By-Pass Valve shown is for reference only.**

- a. Remove engine cowling or reference panels to gain access to the Exhaust By-Pass Valve Assembly.
- b. Apply Mousemilk or Aero Kroil to the bearing surfaces and clevis pivot points during the inspection process. Application of either solution will encourage the removal of unwanted deposits. Lead deposits and carbonized oil (coking) effectively decrease endplay and thereby inhibit the free and unimpeded movement of the wastegate.

- c. After allowing time for the substance to penetrate the surfaces, it is permissible to lightly strike the wastegate shaft with a non-metallic faced hammer or brass drift to release residual lead deposits that have accumulated between the shims, bushings, or valve.

**NOTE:** Be certain not to strike the arm connecting the clevis adjustment rod to the actuator rod as this could irreparably damage the arm or clevis.
