Alert Service Bulletin

Bulletin No. 047

Turbocharger P/N 406610-0005 or -9005 & Turbocharger Center Housing P/N 409836-0005 Recall

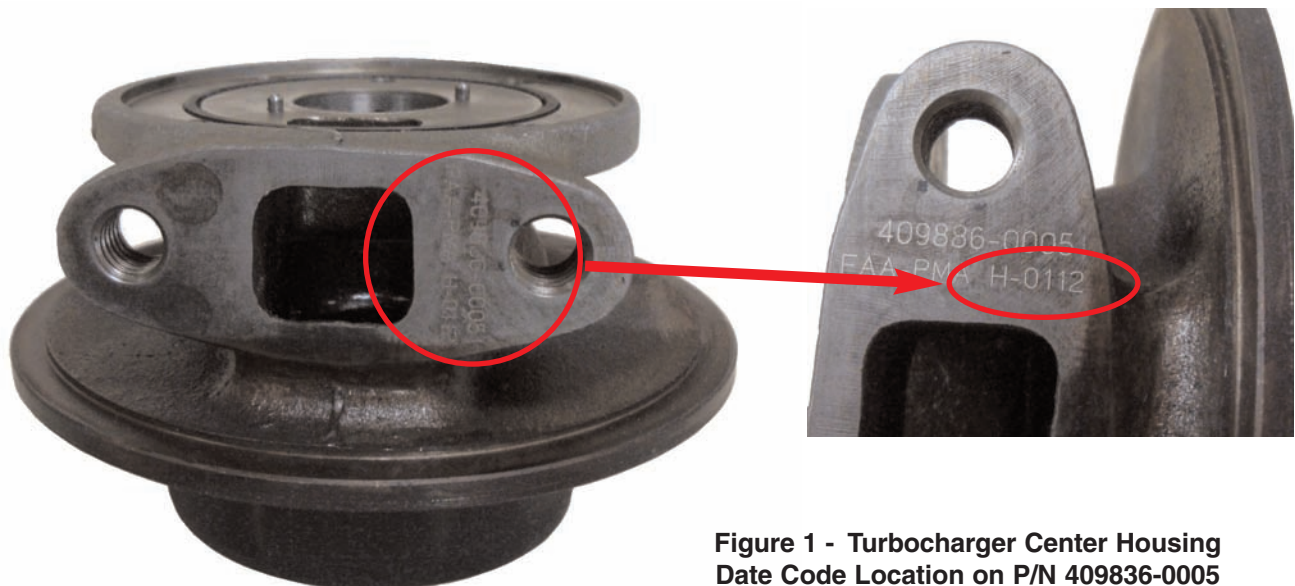
- (c) If the turbocharger was overhauled or repaired January 2012 or later, then determine the center housing date code by removing the oil drain fitting (see Fig. 1).

- (b) If a suspect turbocharger center housing is no longer in inventory and has been placed in service it will be necessary to locate the turbocharger and verify center housing date code by removing the oil drain fitting (see Fig. 1).

Figure 1 - Turbocharger Center Housing
Date Code Location on P/N 409836-0005

- (i) If date code H-0112 is found, continue with Corrective Action 2.
 - (ii) If a date code other than H-0112 is found reconnect the oil drain fitting per applicable aircraft and/or engine manufacturer's maintenance manuals or service instructions. Proceed to "Return to Service".
