# Alert Service Bulletin

**Alert Service Bulletin No. 060 Rev. 1**

**Turbocharger  
P/N 441320-0007 Center Housing Inspection**

This page transmits the revision of Service Bulletin 060 Rev. New to Service Bulletin 060 Rev. 1, dated August 28, 2014.

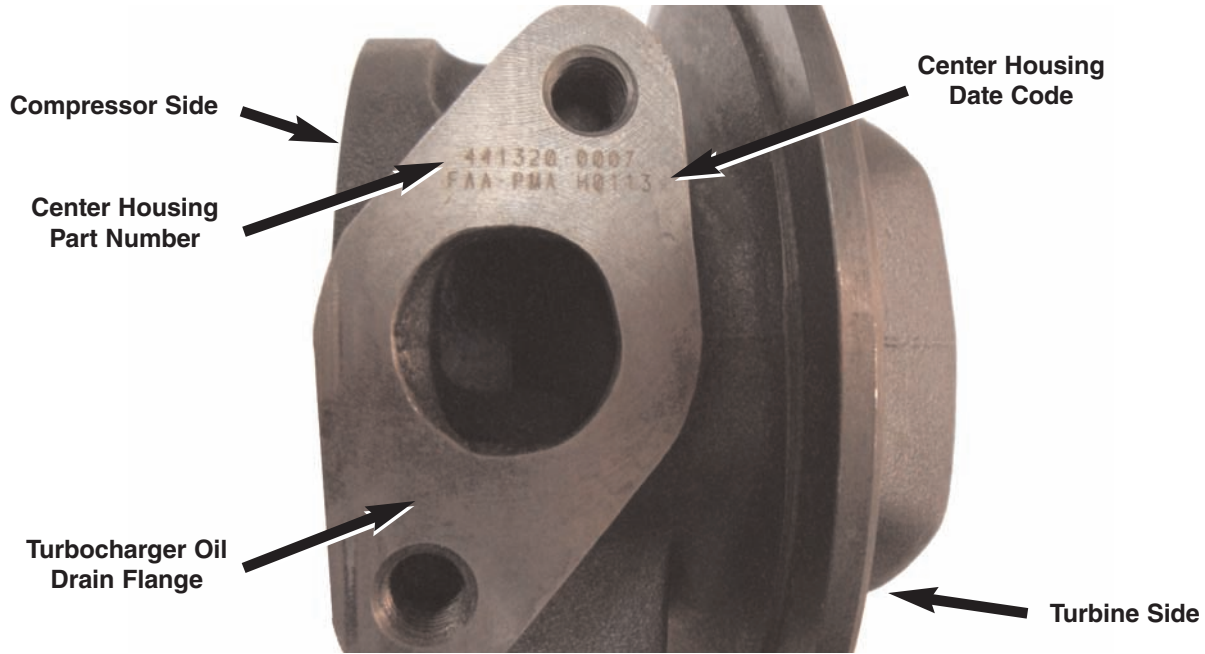
Figure 1 - P/N 441320-0007 Center Housing Date Code Location

- (1) For P/N 441320-0007 Center Housings in inventory, examine the oil drain port flange for an etched date code of H0113. (Refer to Fig. 1.)
- (2) For turbocharger P/N's shown in Table 1 that were field repaired or overhauled between February 1, 2013 and the effective date of this ASB, review aircraft and/or overhaul documentation or remove the turbocharger oil drain reservoir and examine the flange to determine if the P/N 441320-0007 has an affected date code. Refer to Fig. 1.
- (3) If an affected P/N 441320-0007 Center Housing is in inventory or installed and less than twenty-five (25) hours time in service has accrued, perform the following:

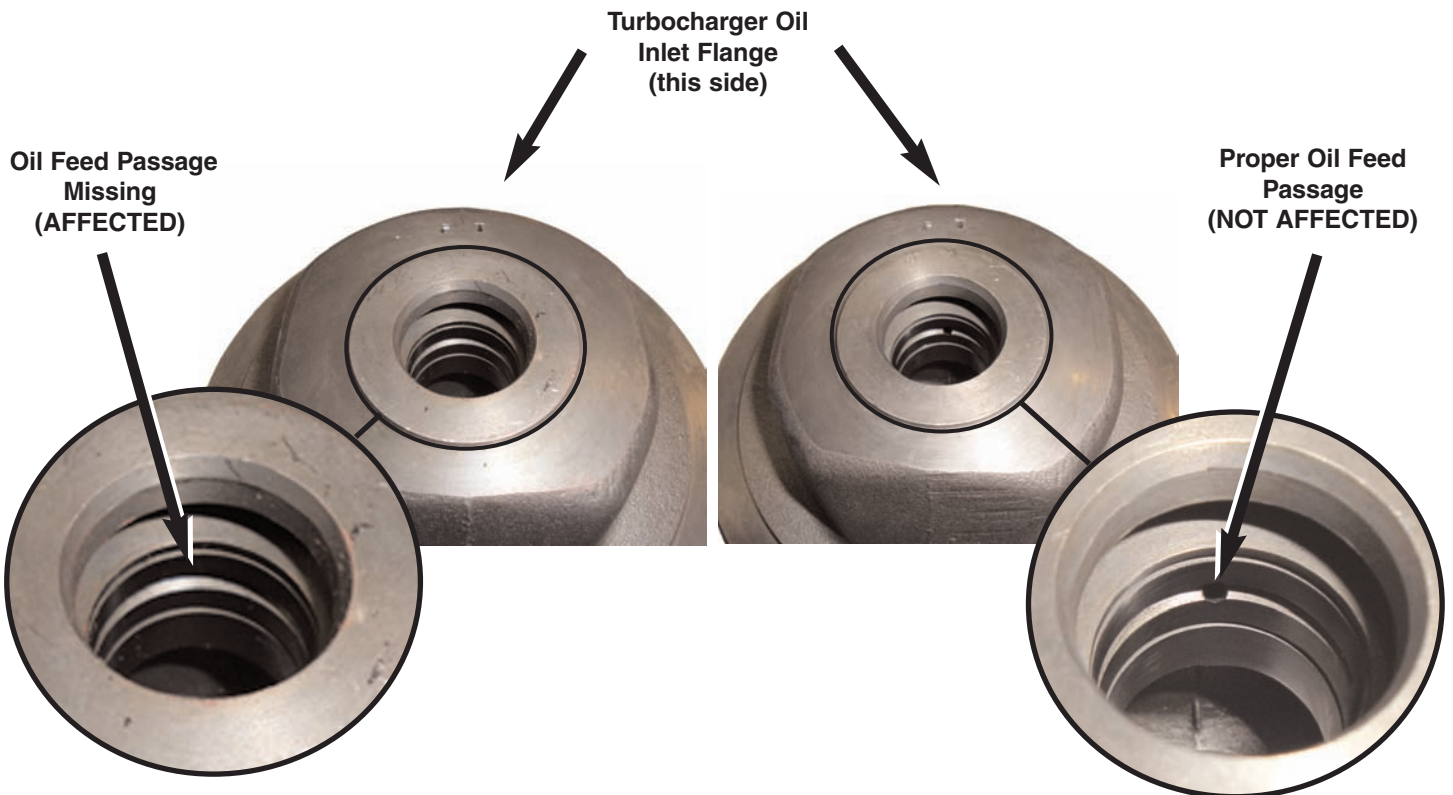
Figure 2 - Identification of P/N 441320-0007 Center Housing Turbine Side Journal Bearing Oil Feed Passage (Turbine Side Shown)

- (1) Hartzell Engine Technologies has discovered that the turbine side journal bearing oil feed passage in some P/N 441320-0007 Center Housings may be missing.
- (2) This condition, if present, will restrict lubrication of the journal bearing which will impair normal operation. Lack of journal bearing lubrication will cause turbocharger seizure within a very short time period with resultant reduction of engine power without warning.
- (3) Loss of lubrication may also lead to component fragmentation which may introduce contaminating particles into the engine.
- (4) Regulatory action is unknown.

- a. If the affected P/N 441320-0007 is installed, disassemble the turbocharger per the HET Turbocharger Overhaul & Maintenance manual P/N 400600-0000 Rev. A or later.
- b. Using white light, visually inspect the turbocharger center housing for the turbine side journal bearing oil feed passage. Refer to Figure 2.
  - (i) If the turbine side journal bearing oil feed passage **IS** present, proceed to Corrective Action 3.B(1).
  - (ii) If the turbine side journal bearing oil feed passage is **NOT** present, proceed to Corrective Action 3.B(2).

- (2) If the turbine side journal bearing oil feed passage is not present:
  - a. Return the affected Center Housing directly to HET within ninety (90) days of the original publication date of this Alert Service Bulletin.

- b. Install a P/N 441320-0007 Center Housing not affected by this Alert Service Bulletin. Do not stamp an "H" on new or unaffected Center Housings.
  - c. Reassemble the turbocharger per instructions in the HET overhaul manual.

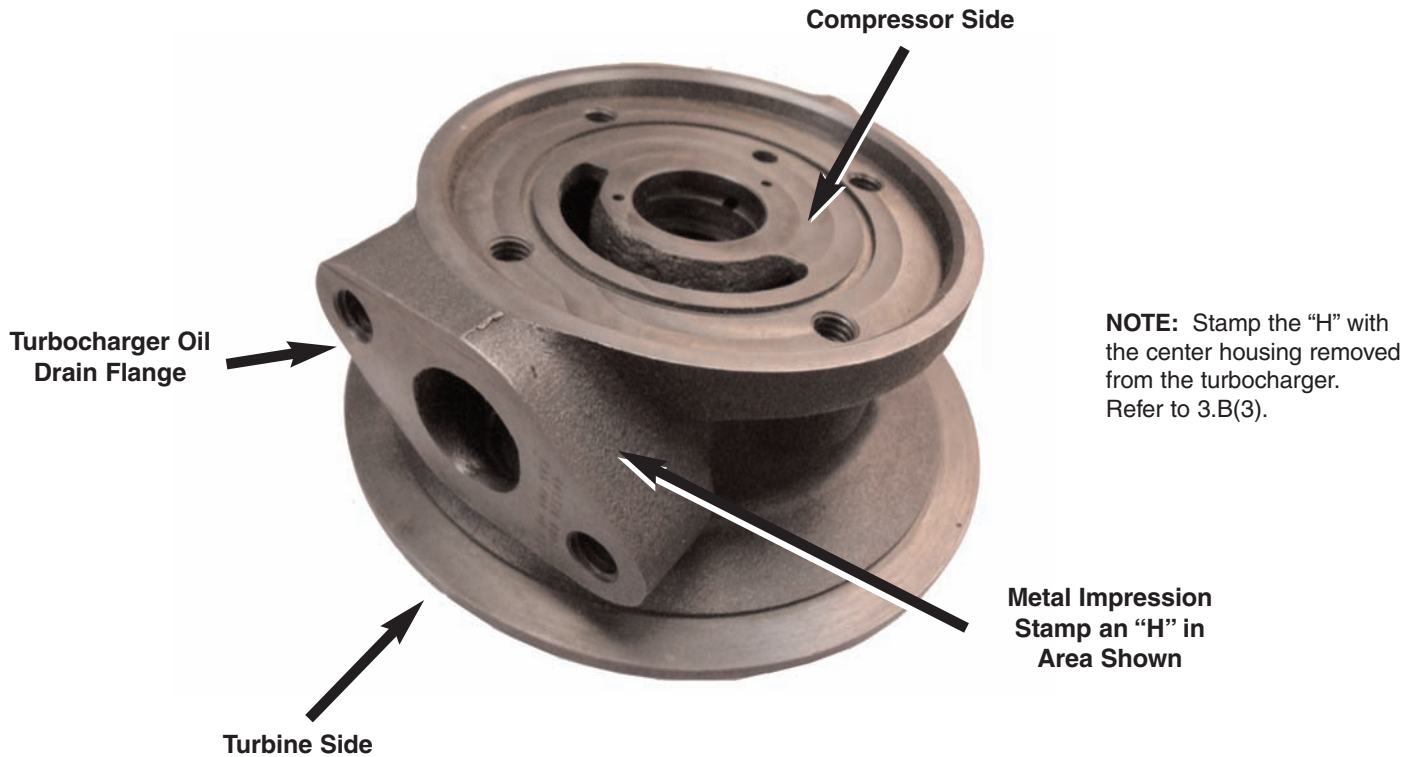
Figure 3 - Identification of P/N 441320-0007 Center Housing NOT Affected - Stamp Location

- (1) Hartzell Engine Technologies LLC (HET) P/N 441320-0007 Center Housing with date code H0113 that are not marked with an "H" as shown in Fig. 3, are affected by this Alert Service Bulletin (ASB). Affected parts would have been received from HET between February 1, 2013 and June 30, 2014.
- (2) All turbocharger part numbers as shown in Table 1 which have been overhauled or repaired using affected P/N 441320-0007 Center Housings with date code H0113 and not marked with an "H" are affected by this Alert Service Bulletin.

- (1) If the turbine side journal bearing oil feed passage is present:
  - a. Identify the Center Housing by applying a metal impression stamp with the letter "H" in the area designated in Figure 3.
