Service Bulletin No. 058

Turbocharger - Back Plate Assembly Replacement at Overhaul

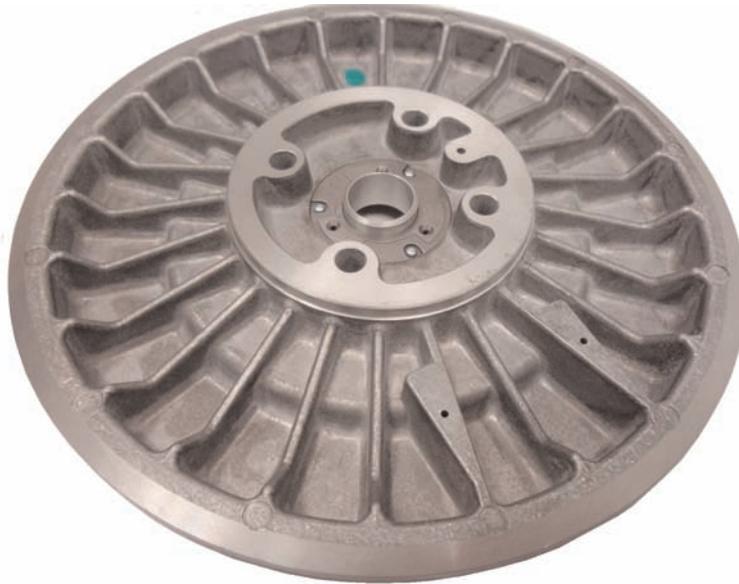
Figure 1 - P/N 406795-0058 Back Plate Assembly

- (1) Hartzell Engine Technologies has replaced P/N 406795-0058 back plate assembly with P/N 490006 back plate assembly.
- (2) The existing die cast back plate is being replaced by an improved geometrically redesigned back plate made from a more robust billet material.

(Affected)
Die Cast Type
Back Plate Shown
(Discontinue use)

This Part To Be
Replaced at Overhaul.

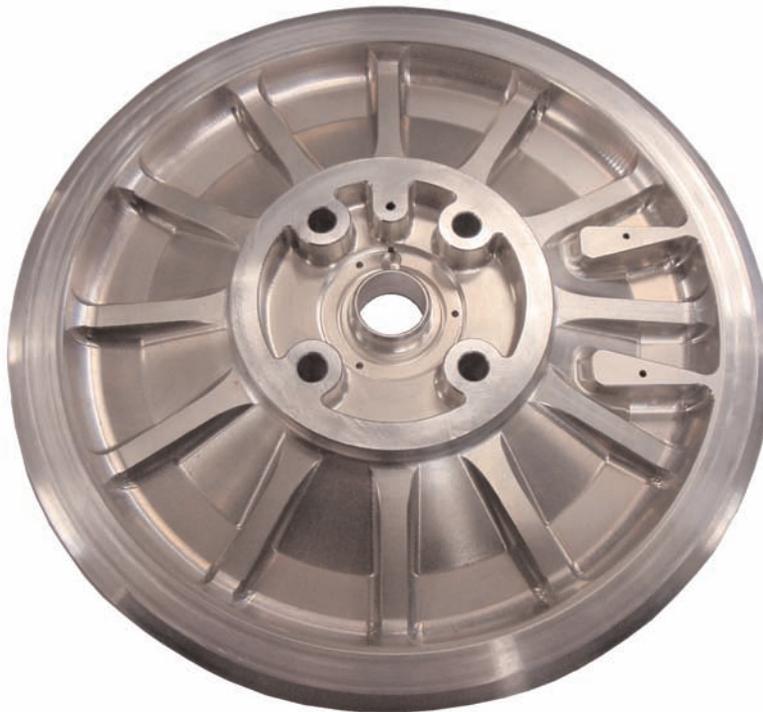
Figure 2 - P/N 490006 Back Plate Assembly (Shown without thrust bearing.)

(NOT Affected)
Non-Cast Type
Back Plate Shown

This Part To Be
Used at Overhaul.
Ref. 3.B(1)
