TURBOCHARGER EXHAUST FLANGE INSPECTION AND/OR TURBINE HOUSING REPLACEMENT (TCM)

REASON FOR REVISION: To clarify effectivity by including RAM P/N 2059-1 cross reference.

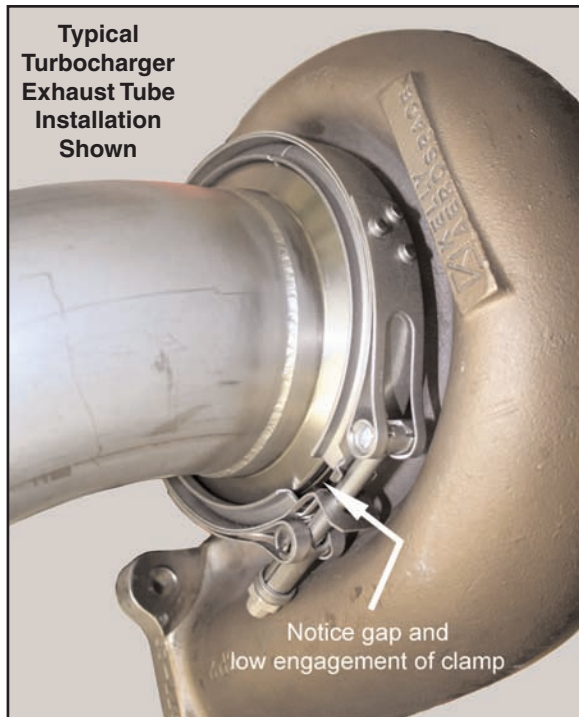
Figure 2 - "V" band Clamp Showing Gap

3. Carefully remove the "V" band clamp from around the turbocharger turbine housing at the turbocharger exhaust outlet taking care not to move the exhaust tube and tail pipe assembly. Figure 2 shows a "V" band clamp improperly installed, notice gap and clamp riding up on flange.

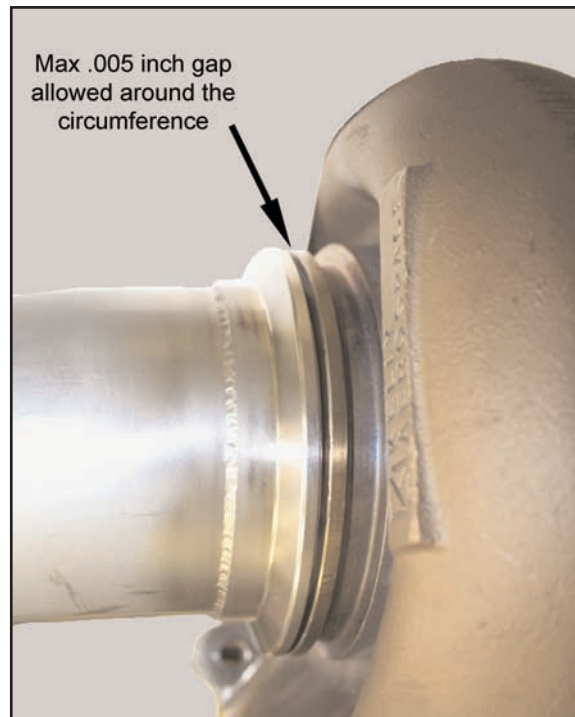
Figure 3 - Gap Inspection Area

4. Inspect the turbocharger turbine housing at the flange area captured by the "V" band clamp. Use a feeler gauge at the split line between the turbine housing flange and the exhaust tube flange all around the circumference. The maximum gap should not exceed .005 inch at any point. **If you suspect or know that the exhaust tube and tail pipe assembly was moved at any point prior to checking for the gap, apply pressure towards the turbine housing flange before taking a measurement.** Refer to Figure 3 on page 4.

5. If a gap exceeding tolerance is found, the turbocharger and tail pipe assembly should be removed. To accomplish this, follow the instructions contained in the Cessna Aircraft or STC holder's maintenance manual or as applicable the appropriate TCM service information. Inspect and clean flange areas using methods recommended by Cessna or TCM. *Do not attempt repair of the turbine housing.* Connect the cleaned exhaust tube to the turbocharger and re-inspect per step 4 above. If the gap still exceeds tolerance, the turbocharger turbine housing (P/N 441977-23 or 441977-25) must be replaced. Proceed to step 6. If gap tolerance is **not exceeded**, metal stamp a 1/8" upper case "I" in the area shown in Fig 4 (per step 7) to indicate the instruction was performed then proceed to step 10.

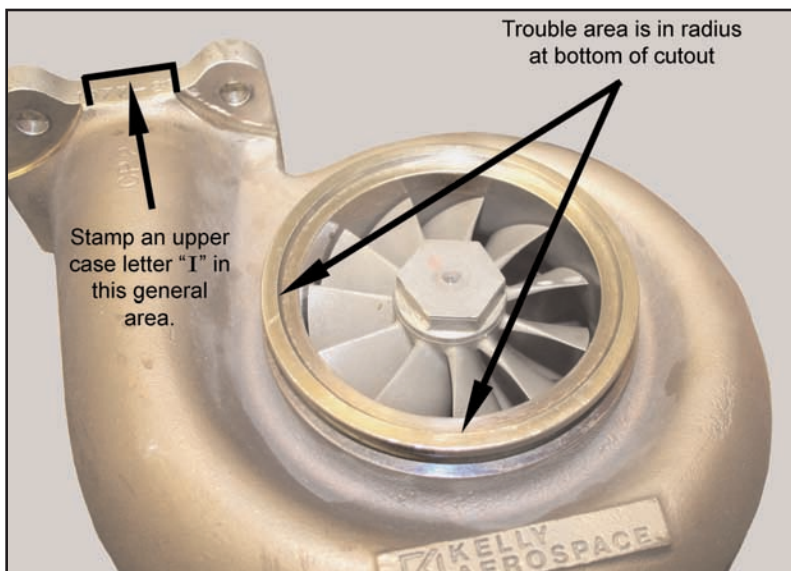
Figure 4 - Turbine Housing Trouble Area

It has come to the attention of Kelly Aerospace Power Systems (KAPS) that a possible interference condition may exist between the turbocharger turbine exhaust outlet flange area and the mating flange of the airframe exhaust tube. The piloted type exhaust tube flange may contact the filet radius of the turbine housing relief cut not allowing the two flange faces to meet properly. (see Figure 3 on page 4) Turbine housings manufactured between August 25, 2006 and January 25, 2008 are suspect. If this condition exists, exhaust pipe security may be compromised. While the exhaust outlet side of the turbocharger turbine has relatively low pressures, the potential of an exhaust leak, a loosening of the "V" band clamp, and a rise of temperature within the engine cowling exist. Left uncorrected, failure of the "V" band clamp may occur with possible loss of the tail pipe connection with resultant uncontained hot exhaust gas within the engine cowl.

6. The turbocharger must be sent to a properly certificated part 145 repair station (or foreign equivalent) experienced in turbocharger repair.
7. Once the turbocharger has been repaired, visually inspect for condition and orientation of the turbine housing then, using a 1/8" metal stamp of an upper case "I", stamp the turbine housing in the area shown in Figure 4. Care must be taken not to extend stamp within 1/8" of the mating edge as it may bulge and distort the mating surface. When stamped, proceed with the installation.
8. Utilizing the applicable aircraft, STC holder and/or engine manufacturers maintenance manuals or service instructions, re-install the turbocharger assembly.
