TURBOCHARGER EXHAUST FLANGE INSPECTION AND/OR TURBINE HOUSING REPLACEMENT (PARTS)

It has come to the attention of Kelly Aerospace Power Systems (KAPS) that a possible interference condition may exist between the turbocharger turbine exhaust outlet flange area and the mating flange of the airframe exhaust tube. The piloted type exhaust tube flange may contact the filet radius of the turbine housing relief cut not allowing the two flange faces to meet properly. (see Figure 2 on page 4) Turbine housings manufactured between August 25, 2006 and January 25, 2008 are suspect. If this condition exists, exhaust pipe security may be compromised. While the exhaust outlet side of the turbocharger turbine has relatively low pressures, the potential of an exhaust leak, a loosening of the "V" band clamp, and a rise of temperature within the engine cowling exist. Left uncorrected, failure of the "V" band clamp may occur with possible loss of the tail pipe connection with resultant uncontained hot exhaust gas within the engine cowl.

This Service Bulletin is being issued to mandate the inspection and/or replacement of affected turbocharger turbine housing(s) P/N 441977-0023 and 441977-0025. These

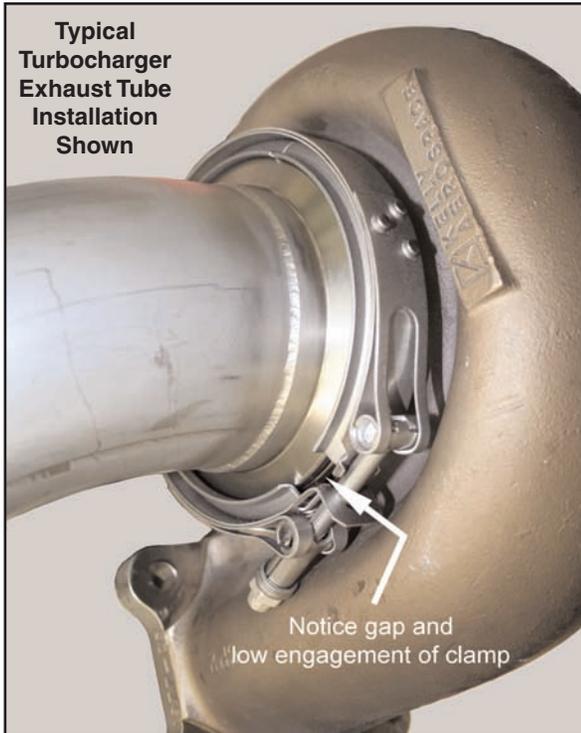
Figure 1 - "V" band Clamp Showing Gap

3. Carefully remove the "V" band clamp from around the turbocharger turbine housing at the turbocharger exhaust outlet taking care not to move the exhaust tube and tail pipe assembly. Figure 1 shows a "V" band clamp improperly installed, notice gap and clamp riding up on flange.

If the existing "V" band clamp is to be used, it should be inspected for damage on the inside of the "V" prior to re-use. If the inside radius of the "V" is flattened or cut it should not be used. Obtain the clamp part number from the appropriate aircraft or engine parts catalog.

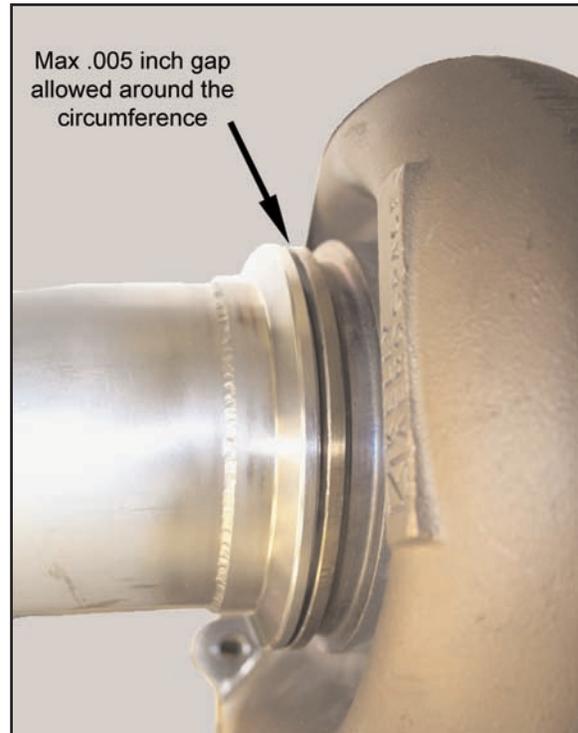
Figure 2 - Gap Inspection Area

4. Inspect the turbocharger turbine housing at the flange area captured by the "V" band clamp. Use a feeler gauge at the split line between the turbine housing flange and the exhaust tube flange all around the circumference. The maximum gap should not exceed .005 inch at any point. ***If you suspect or know that the exhaust tube and tail pipe assembly was moved at any point prior to checking for the gap, apply pressure towards the turbine housing flange before taking a measurement.*** Refer to Figure 2 on page 4.

5. If a gap exceeding tolerance is found, the turbocharger and tail pipe assembly should be removed. To accomplish this, follow the instructions contained in the applicable aircraft, STC holder, or engine maintenance manual or service information. Inspect and clean flange areas using methods recommended by the applicable airframe or engine manufacturer. *Do not attempt repair of the turbine housing.* Connect the cleaned exhaust tube to the turbocharger and re-inspect per step 4 above. If the gap still exceeds tolerance, the turbocharger turbine housing (P/N 441977-0023 or 441977-0025) must be replaced. Proceed to step 6. If gap tolerance is ***not exceeded***, metal stamp an upper case "I" in accordance with instructions found in step 7 in the area shown in Fig 3 to indicate the instruction was performed then proceed to step 10.

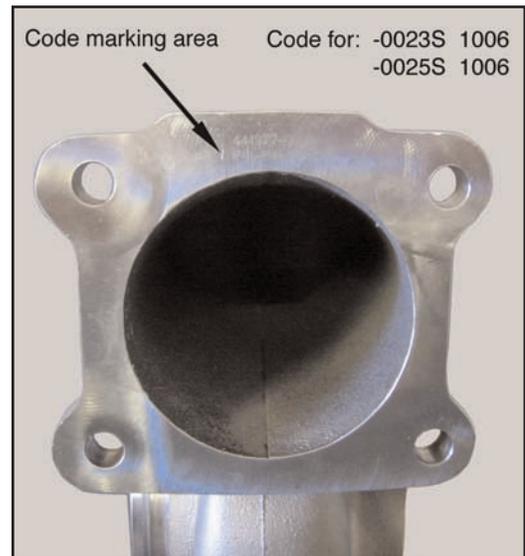
Figure 4 - Spare Part Code Marking

Any KAPS turbocharger using a P/N 441977-0023S as a repair or overhaul replacement part or which may be in unused inventory. *Turbine housings of this part number were produced October, 2006 marked 1006 underneath the part number. See spare part notes on page 2 and Figure 4 on page 4.*

Any KAPS turbocharger using a P/N 441977-0025S as a repair or overhaul replacement part or which may be in unused inventory. *Turbine housings of this part number were produced October, 2006 marked 1006 underneath the part number. See spare part notes on page 2 and Figure 4 on page 4.*

Identification of the affected P/N 441977-0023S and 441977-0025S turbine housings sold as spare parts may be accomplished by observing the code markings on the inlet flange mating surface of the housing. *See Figure 4 on page 4.*

Any unused turbocharger which appears on the Suspect Serial Number Table(s) on page 2 in stock may be returned for repair or replacement. Any unused turbine housing, P/N 441977-0023S or P/N 441977-0025S sold from October 2006 through January 25, 2008 with code number 1006 which remains in stock. *See Figure 4 on page 4.*
