TURBOCHARGER EXHAUST FLANGE INSPECTION AND/OR TURBINE HOUSING REPLACEMENT

This Service Bulletin is being issued to mandate the inspection and/or replacement of affected turbocharger turbine housing(s) P/N 441977-25 as found on KAPS turbocharger P/N 409170-0001 (Lyc LW-12463) per the serial numbers listed in the table below.

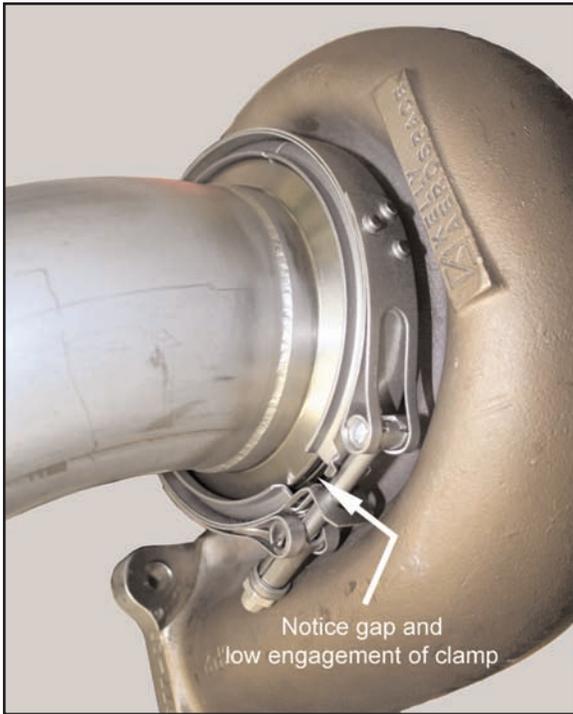
Figure 2 - "V" band Clamp Showing Gap

3. Carefully remove the "V" band clamp from around the turbocharger turbine housing at the turbocharger exhaust outlet taking care not to move the exhaust tube and tail pipe assembly. Figure 2 shows a "V" band clamp improperly installed, notice gap and clamp riding up on flange.

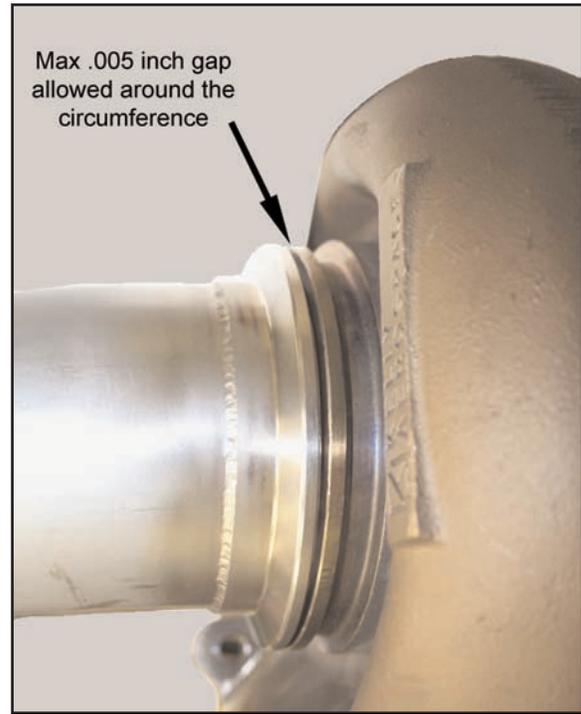
Figure 3 - Gap Inspection Area

4. Inspect the turbocharger turbine housing at the flange area captured by the "V" band clamp. Use a feeler gauge at the split line between the turbine housing flange and the exhaust tube flange all around the circumference. The maximum gap should not exceed .005 inch at any point. **If you suspect or know that the exhaust tube and tail pipe assembly was moved at any point prior to checking for the gap, apply pressure towards the turbine housing flange before taking a measurement.** Refer to Figure 3 on page 3.

5. If a gap exceeding tolerance is found, the turbocharger and tail pipe assembly should be removed. To accomplish this, follow the instructions contained in the Piper Aircraft or STC holder's maintenance manual or as applicable the appropriate Lycoming service information. Inspect and clean flange areas using methods recommended by Piper or Lycoming. *Do not attempt repair of the turbine housing.* Connect the cleaned exhaust tube to the turbocharger and re-inspect per step 4 above. If the gap still exceeds tolerance, the turbocharger turbine housing (P/N 441977-25) must be replaced. If gap tolerance is **not exceeded**, metal stamp a 1/8" upper case "I" in the area shown in Fig 4 (per step 7) to indicate the instruction was performed then proceed to step 10.

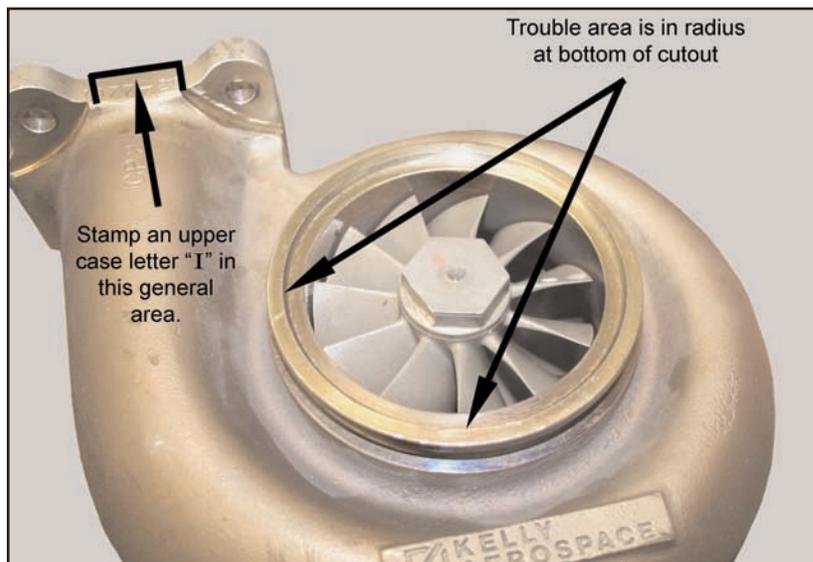
Figure 4 - Turbine Housing Trouble Area

It has come to the attention of Kelly Aerospace Power Systems (KAPS) that a possible interference condition may exist between the turbocharger turbine exhaust outlet flange area and the mating flange of the airframe exhaust tube. The piloted type exhaust tube flange may contact the filet radius of the turbine housing relief cut not allowing the two flange faces to meet properly. (see Figure 3 on page 3) Turbine housings manufactured between August 25, 2006 and October 12, 2007 are suspect. If this condition exists, exhaust pipe security may be compromised. While the exhaust outlet side of the turbocharger turbine has relatively low pressures, the potential of an exhaust leak, a loosening of the "V" band clamp, and a rise of temperature within the engine cowling exist. Left uncorrected, failure of the "V" band clamp may occur with possible loss of the tail pipe connection with resultant uncontained hot exhaust gas within the engine cowl.

6. Upon removal, the turbocharger must be sent to a properly certificated part 145 repair station (or foreign equivalent) experienced in turbocharger repair.
7. Once the turbocharger has been repaired and returned, visually inspect for condition and orientation of the turbine housing then, using a 1/8" metal stamp of an upper case "I", stamp the turbine housing in the area shown in Figure 4. Care must be taken not to extend stamp within 1/8" of the mating edge as it may bulge and distort the mating surface. When stamped, proceed with the installation.
8. Utilizing the applicable aircraft, engine, and/or STC holders maintenance manuals or service instructions, re-install the turbocharger assembly.
