Alert Service Bulletin No. 074 Rev. A

Turbocharger Center Housing Inspection

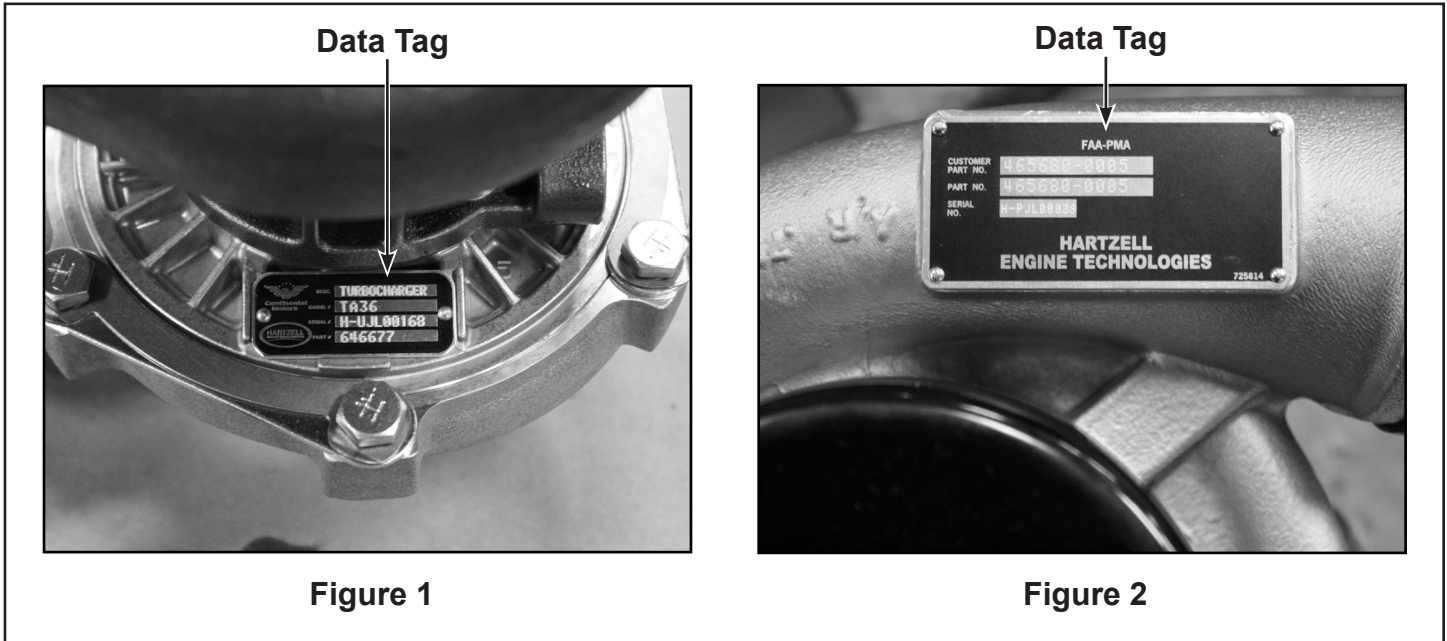
Turbocharger Data Tag Locations
Figures 1 & 2

NOTE : The turbocharger data tag can be found in one of two locations depending on model. Refer to Figures 1 & 2 for locations.

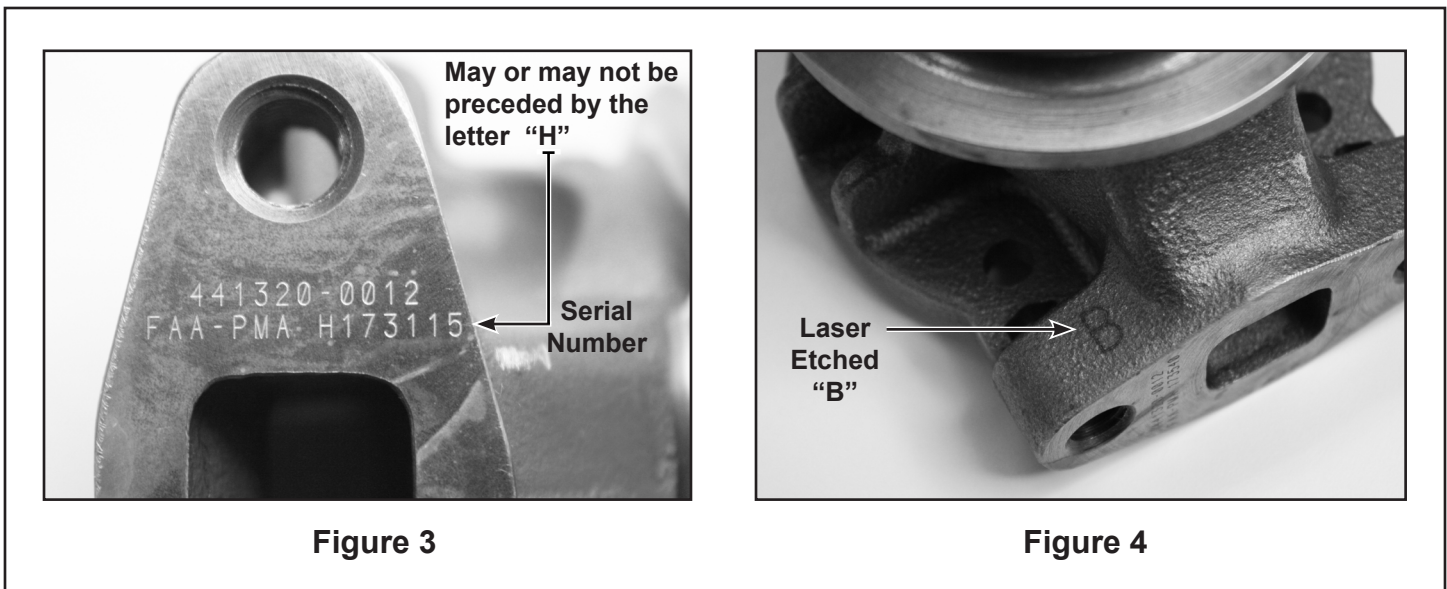
Turbocharger Center Housing Oil Drain (lower) Flange
Figures 3 & 4

- (3) If the turbocharger was serviced between 10 May, 2017 and the effective date of this ASB, and effectivity cannot be established from the maintenance records, utilize the applicable aircraft maintenance manual to gain access to and remove the turbocharger center housing oil drain line from (lower) flange. Inspect turbocharger center housing serial number against affected serial numbers found in Table 2 of this ASB. (See Figure 3 for serial number illustration)

NOTE: Serial numbers found in Table 2 may or may not be preceded by the letter “H” as shown in Figure 3.

- (1) Affected turbochargers and/or center housings
 - (a) Replace turbocharger center housing with one not associated with this ASB.
 - 1 Replacement center housing may be new or factory reworked.
 - 2 Factory reworked center housings will be identified by a laser etched “B” located on the side of the oil drain flange (See Figure 4).
