## SERVICE BULLETIN No. 058 Rev. A

### **Turbocharger - Back Plate Assembly Replacement at Overhaul**

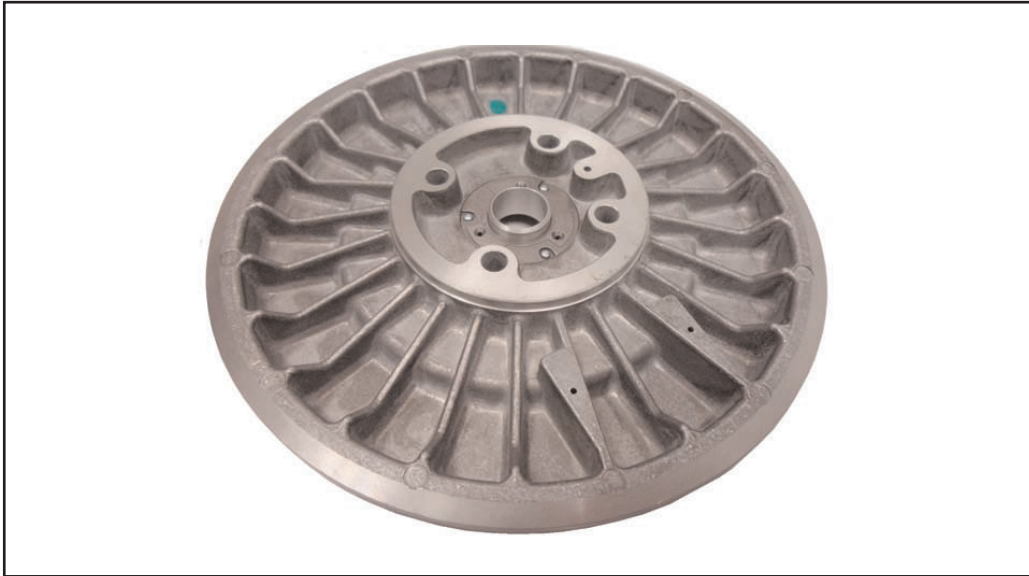
**Figure 1 - P/N 406795-058 Back Plate Assembly**

(a) At overhaul, identify P/N 406795-0058 back plate assembly by visual inspection (no disassembly required). Refer to Fig. 1.

1) If this back plate assembly is installed, proceed to section 3.B(1) Corrective Action.

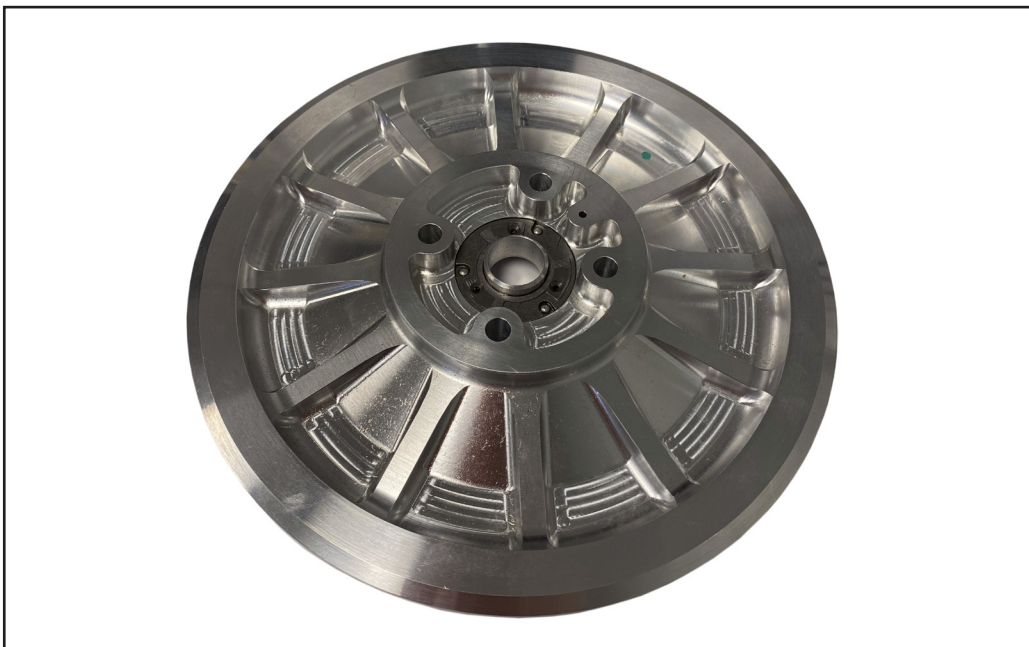
**Figure 2 - P/N 490006 Back Plate Assembly (Billet)**

(b) If the turbocharger has been overhauled or repaired previously, P/N 490006 (Fig. 2) or 490045-0000 (Fig. 3) back plate assembly may already be installed. This may be confirmed by visual inspection. (Refer to Figures 2 & 3)
