SERVICE BULLETIN No. 088

Turbocharger Center Housing Inspection

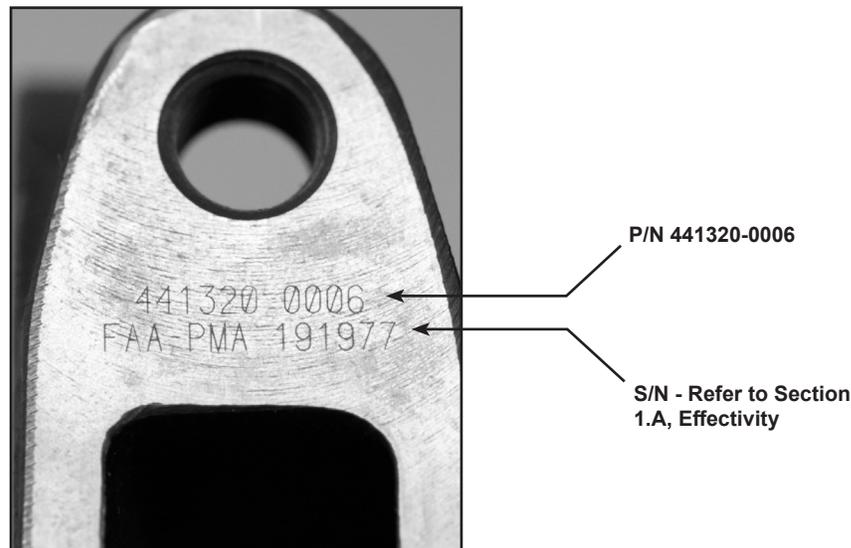
Figure-1 - Center Housing Identification

- (a) If the turbocharger **is** affected, utilize the applicable aircraft maintenance manual to gain access to and remove the turbocharger center housing oil drain line from (lower) flange. Inspect the turbocharger center housing P/N and S/N against criteria found in section 1.A of this SB. (See Figure-1 for serial number illustration)
