Service Bulletin

Service Bulletin No. 203

Undersized Turbocharger Journal Bearing

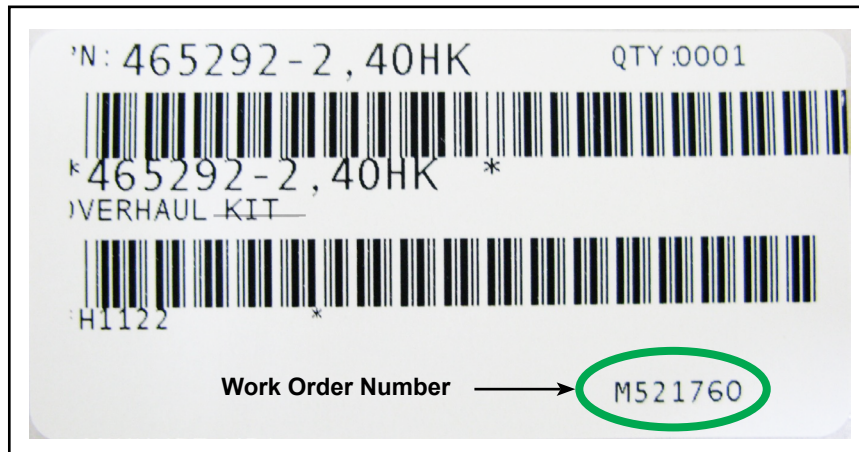
Figure 1 - Overhaul Kit Label

Overhaul Kit P/N	Work Order Number *
465292-2, 4OHK	M521760
	M539140
	M594240
	M683290
465398-2OHK	M683300
466011-2OHK	M585130
	M645270
	M665190
	M683310
	M705810
4466304-3OHK	M493570
	M521700
	M521710
	M535540
	M539050
	M539060
	M539070
	M594170
	M594180
	M645290
	M664370
	M665150
	M665160
466642-1, 2OHK	M521780
	M534500
	M594220
	M665130
	M683280
* Refer to Figure 1, Overhaul Kit Label, for Work Order Number Identification

* Refer to Figure 1, Overhaul Kit Label, for Work Order Number Identification
