# Service Bulletin

## Service Bulletin No. 205

### Turbocharger V-Band Torque Verification

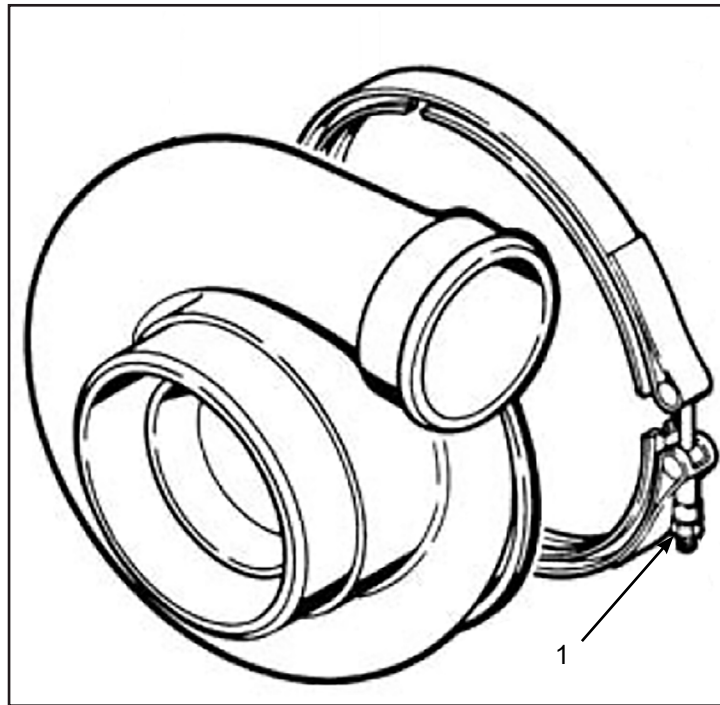
Figure 1 - Turbocharger V-Band Coupling, Typical

- (1) Hartzell Engine Tech has discovered that affected turbocharger v-band lock-nut (1) torque specifications referenced in 400600-0000 Rev. New thru Rev. D are incorrect.
  - (a) This condition could compromise the integrity of the v-band retention system.

- (1) V-band torque check
  - (a) Gain access to the turbocharger in accordance with applicable aircraft/engine maintenance manual and service instructions.
    - 1) Inspect the v-band coupling for looseness.
      - a) If the v-band coupling is found loose on the housing:
        - 1: Contact HET customer support prior to taking action.
      - b) If the v-band coupling is not found loose on the housing:
        - 1: Using a calibrated in-lb torque wrench, inspect the v-band coupling lock-nut (1) torque against the turbocharger models referenced in Table 2, this document.
        - 2: If the locknut (1) torque is not within specification, adjust torque in accordance with Table 2.
        - 3: If the locknut (1) torque is within limits, continue to 3.C, Return to service.
