# Alert Service Bulletin

## Alert Service Bulletin No. 210 Turbocharger Turbine Housing Inspection

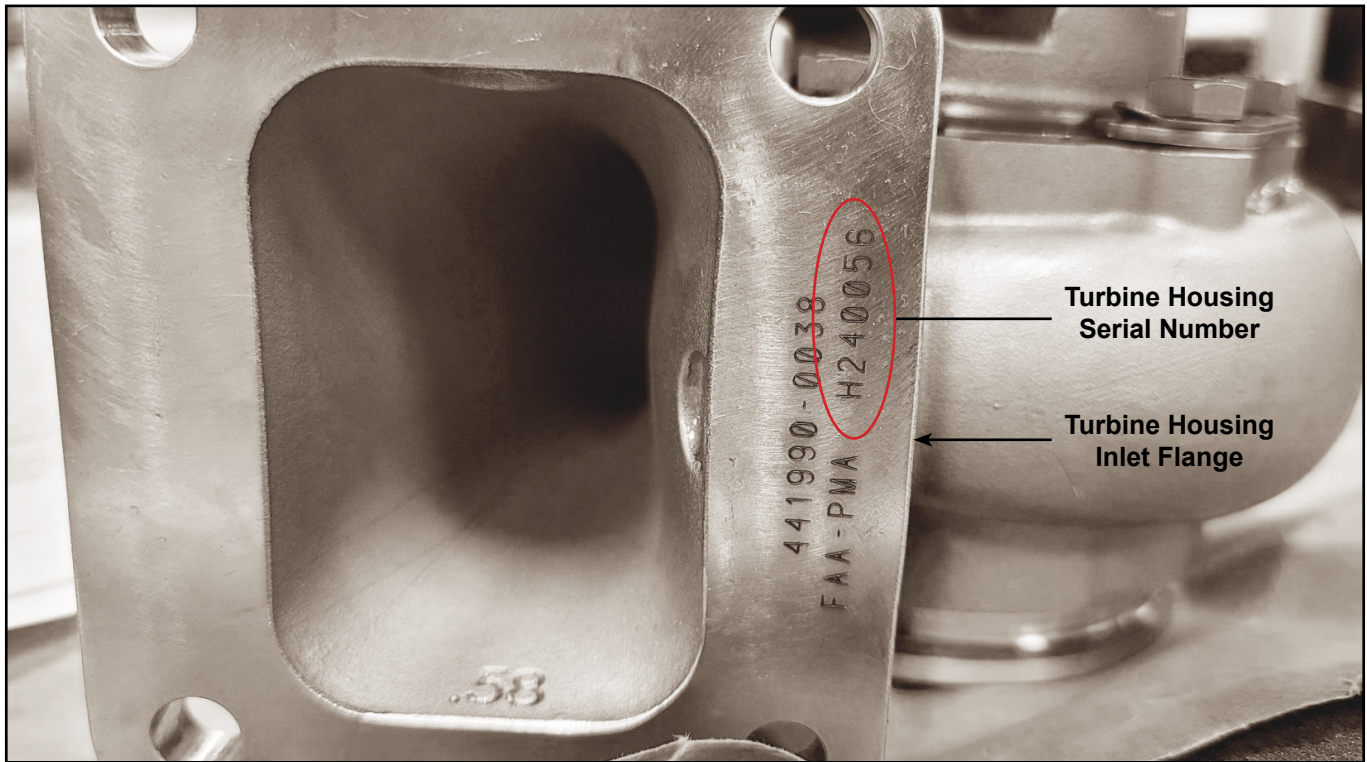
Figure-1 - Turbocharger Turbine Housing Serial Number Location\*

- (1) Gain access to the turbocharger inlet flange in accordance with the latest engine/airframe service instructions or maintenance manual.
- (2) Locate and record the serial number located on the turbine housing inlet flange. See Figure-1.
  - (a) If the turbine housing serial number **is** affected, continue to section 3.C., Corrective Action.
  - (b) If the turbine housing serial number is **not** affected, install any components that were removed to gain access in accordance with the latest engine/airframe service instructions or maintenance manual. Continue to 3.E.(2), Maintenance Record.

\* Reference to serial number location only. Turbo housing P/N shown is not affected.
