Alert Service Bulletin

Alert Service Bulletin No. 213

Turbocharger Turbine Housing Bolt P/N 400132-0301 Inspection

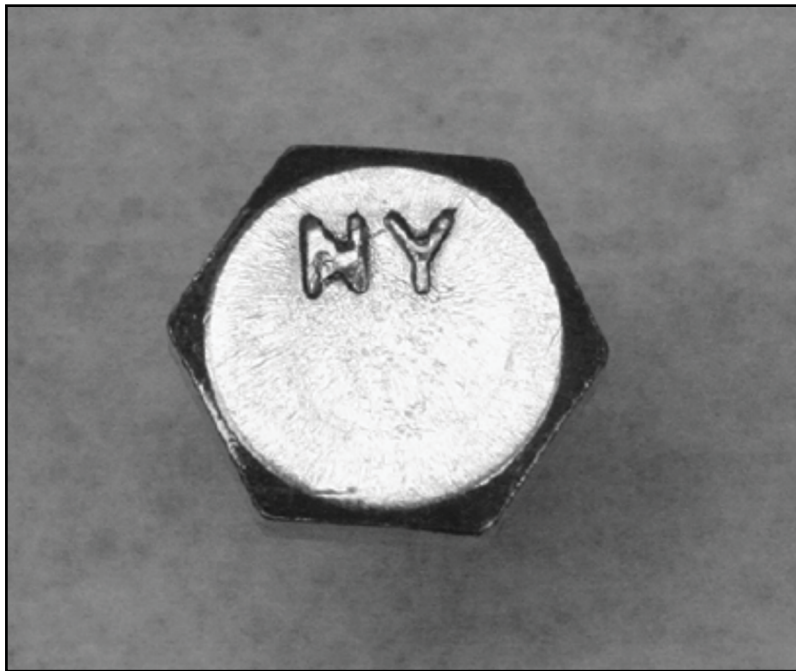
Figure-1 - Nonconforming Bolt

- (1) Gain access to the turbocharger in accordance with the latest engine/airframe service instructions or maintenance manual.
- (2) Locate the six turbine housing bolts (1) and inspect the bolts against Figure-1.
 - (a) A nonconforming bolt is labeled with the raised letters NY.
 - 1) If one or more of the six bolts **are** affected, continue to section 3.C., Corrective Action.
 - 2) If no bolts are affected, install any components that were removed to gain access in accordance with the latest engine/airframe service instructions or maintenance manual. Continue to 3.E., Maintenance Record.
