TURBOCHARGER EXHAUST FLANGE INSPECTION AND/OR TURBINE HOUSING REPLACEMENT (TCM)

REASON FOR REVISION: To clarify effectivity by including RAM P/N 2059-1 cross reference.

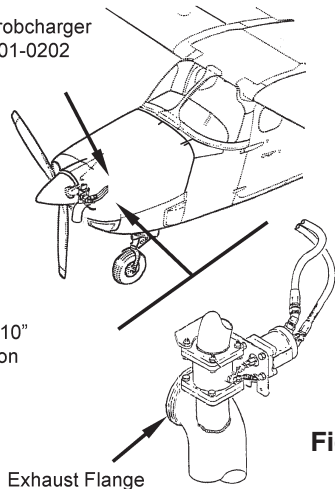
Typical "210"
Installation

Cessna Turbocharger
P/N C295001-0202

1. Access the aircraft turbocharger by removing the cowling as required in accordance with the instructions contained in the Cessna Aircraft maintenance manual. Refer to appropriate aircraft in Figure 1.

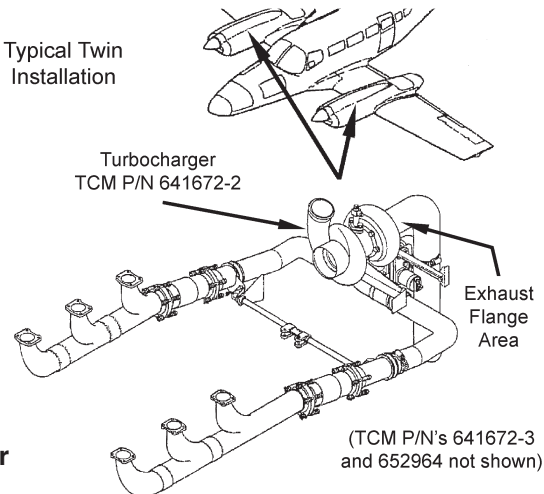
**Figure 1 - Turbocharger
Installation**

Typical Twin
Installation

Turbocharger
TCM P/N 641672-2

Exhaust
Flange
Area
